## Marine Safety Information Bulletin

22-24

Lydia Ann Channel

Issue Date: April 5, 2024

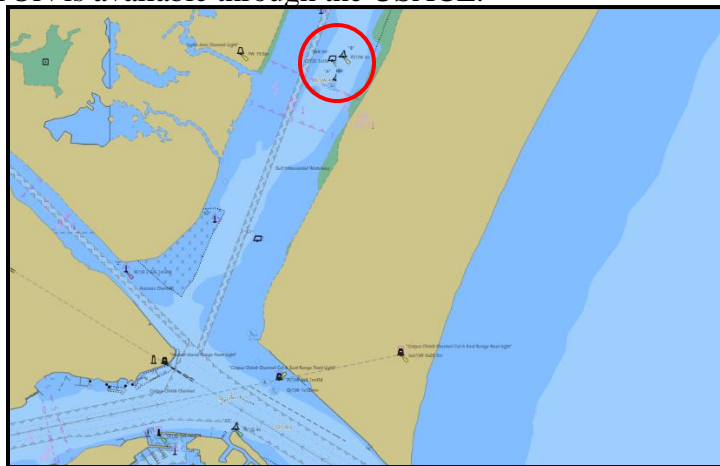
The wreck is parallel to the Lydia Ann Channel and located south of the Lydia Ann Channel Fleet. The extent of the wreckage is contained between the follow estimated coordinates: 27°51'49.67"N, 097°02'58.47"W; 27°51'49.06"W, 097°02'59.13"W; 27°51'46.59"N, 097°03'00.09"W; 27°51'45.38"N, 097°03'00.11"W; 27°51'46.3"N, 097°02'59.42"W; 27°51'48.90"N, 097°02'58.43"W; and 27°51'49.67"N, 097°02'58.47"W. The USS JOHN WORTHINGTON is marked with Aransas Bay Alternate Route lighted buoy "WR59", lighted danger buoy "A", and lighted danger buoy "B". Aids to navigation discrepancy reports can be made through the U.S. Coast Guard Navigation Center at [ATON Discrepancy Report Form | Navigation Center \(uscg.gov\)](#) or to the U.S. Coast Guard Sector Corpus Christi Command Center at 1-800-874-2143.

The U.S. Army Corps of Engineers (USACE) has provided updated survey data of the USS JOHN WORTHINGTON, a World War I era tanker sunk in the vicinity of the Lydia Ann Channel. [Survey data](#) of the USS JOHN WORTHINGTON is available through the USACE.
